Tru-Brix

TECHNICAL DATA AND TEST RESULTS

Technical Data and Test Results

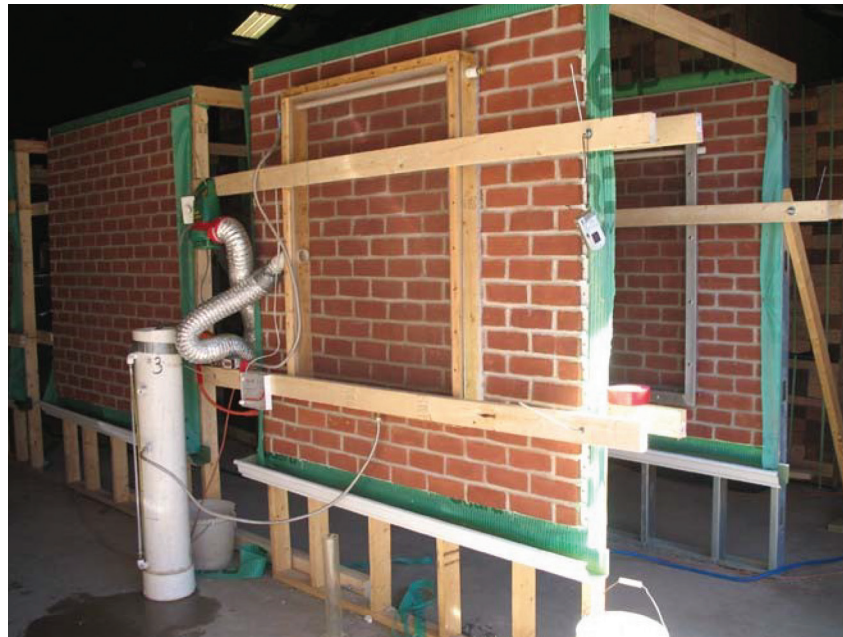
Figure 1

E514 Test Chamber on Wood Stud Sample Wall (foreground) and Metal Stud Wall (behind).

Type 2; Tru-Brix siding installed over $\frac{5}{8}$ " Fiberglass faced exterior gypsum sheathing (Georgia Pacific Dens-Glass Gold) on 18 gauge steel studs spaced at 16" on center. Three wall samples of 6' x 6' were built and two were tested. The E514 Test chamber was 40" W x 48" H and attached in the approximate center horizontally, and 2 courses from the top, on each test wall. (See Figure 1)

The test walls were constructed with a trough below the test area to collect water. (See Figure 1) The procedure called for measuring the water that was collected in the trough, measuring any water that might penetrate into the drainage wrap and drain to the bottom of the test panel, and observing any wetness behind the sheathing with emphasis on monitoring the screw penetrations.

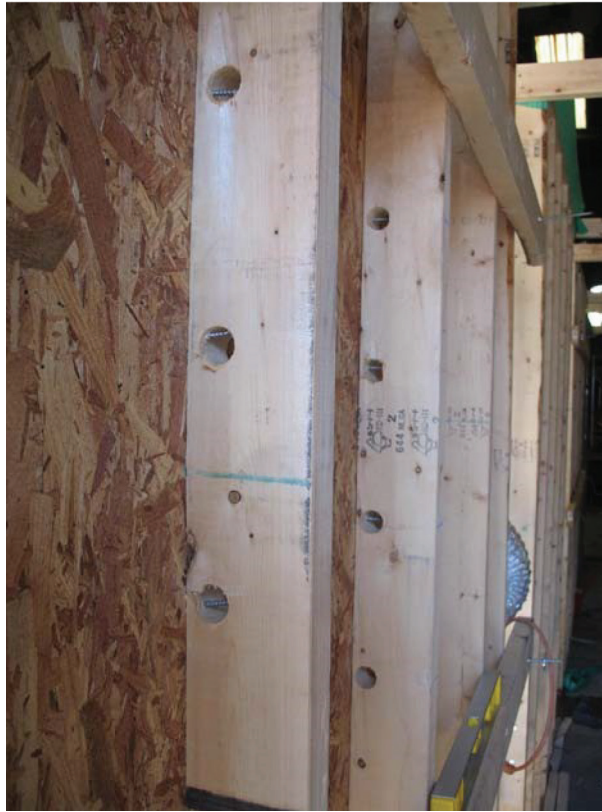
Figure 2
Observation holes at anchoring screws in wood studs.

Test Samples: Type 1; Tru-Brix Siding installed over $\frac{7}{16}$ " OSB Sheathing on untreated 2" x 4" wood studs spaced at 16" on center. Three wall samples of 6' x 6' were built and two were tested. The E514 Test chamber was 40" W x 48" H and attached in the approximate center horizontally, and 2 courses from the top, on each test wall. (See Figure 1) Holes were drilled in the wood studs close to the sheathing in order to expose eight Siding attachment screws for observation. (See Figure 2)

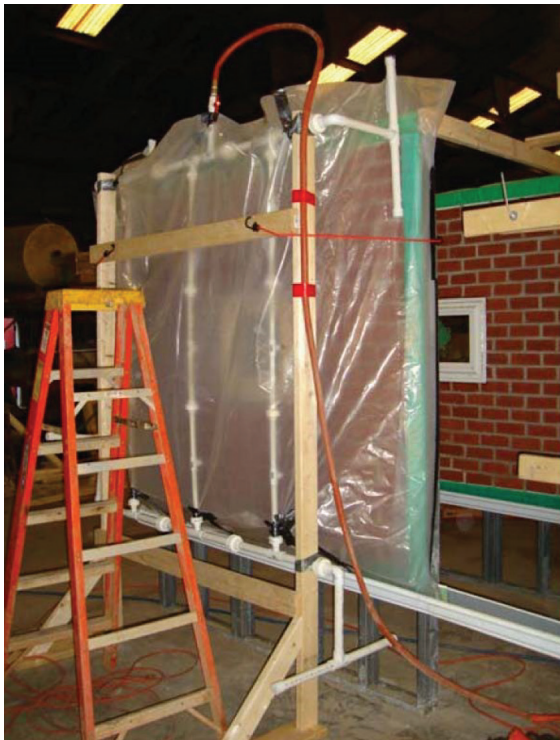
Figure 3
E1105 Setup

Test Samples: Test samples: Type 1; Tru-Brix Siding installed over $\frac{5}{8}$ " Fiberglass faced exterior gypsum sheathing (Georgia Pacific Dens-Glass Gold) on 18 gauge steel studs spaced at 16" on center. A flanged 16" x 16" fixed window was installed with standard construction methods. The E1109 spray test apparatus was set up and plastic covering was installed around the test apparatus. See Figure 3.

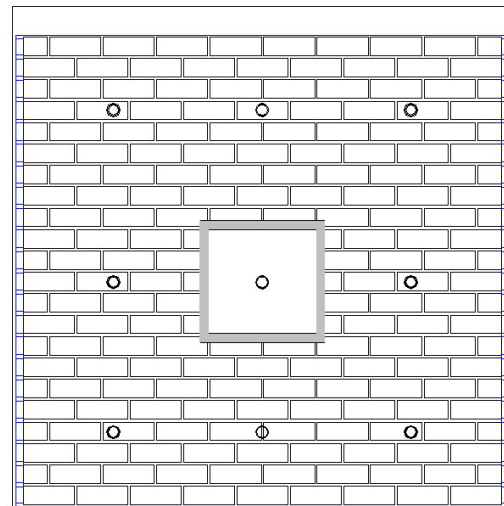
Figure 4
Spray Nozzle Locations

Test procedure: Nine spray nozzles were aimed at the test walls as indicated in Figure 4. Water was applied for two 15-minute periods with a 10-minute wait between applications.

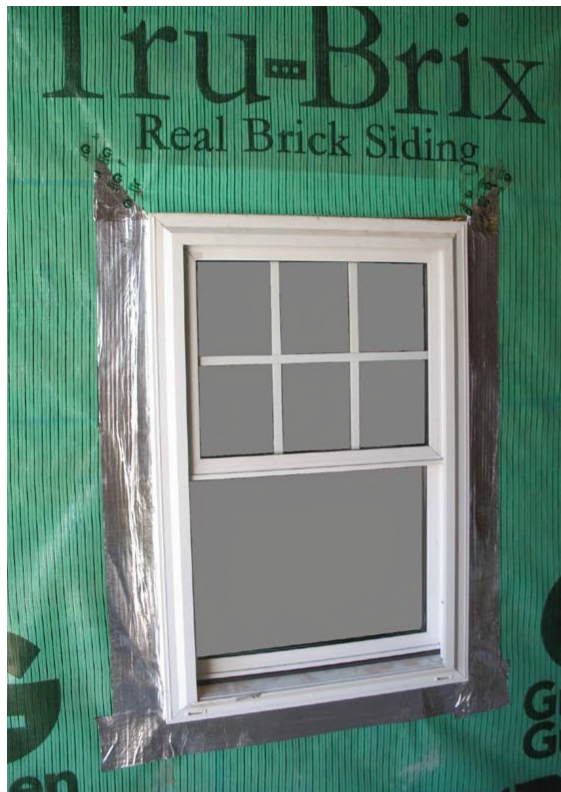
Figure 5
Window with Drainage Wrap and Flashing.

Test Method: Examinations of the results show that correct window flashing details are required to prevent water penetration at window heads. The correct installation is shown in Figure 5. The Drainage Wrap must be cut to install window head flashing underneath the Wrap. Any moisture in the Drainage Wrap will then be removed from the wall by the window head flashing.
